Stray Voltage Investigation by Vitatech Electromagnetics, LLC

National Regulatory Research Institute (NRRI) www.nrri.ohio-state.edu The Ohio State University Columbus, Ohio Ray Lawton, Director Robert Burns, Electric Research

Initial Meeting & Information 9 October 2002

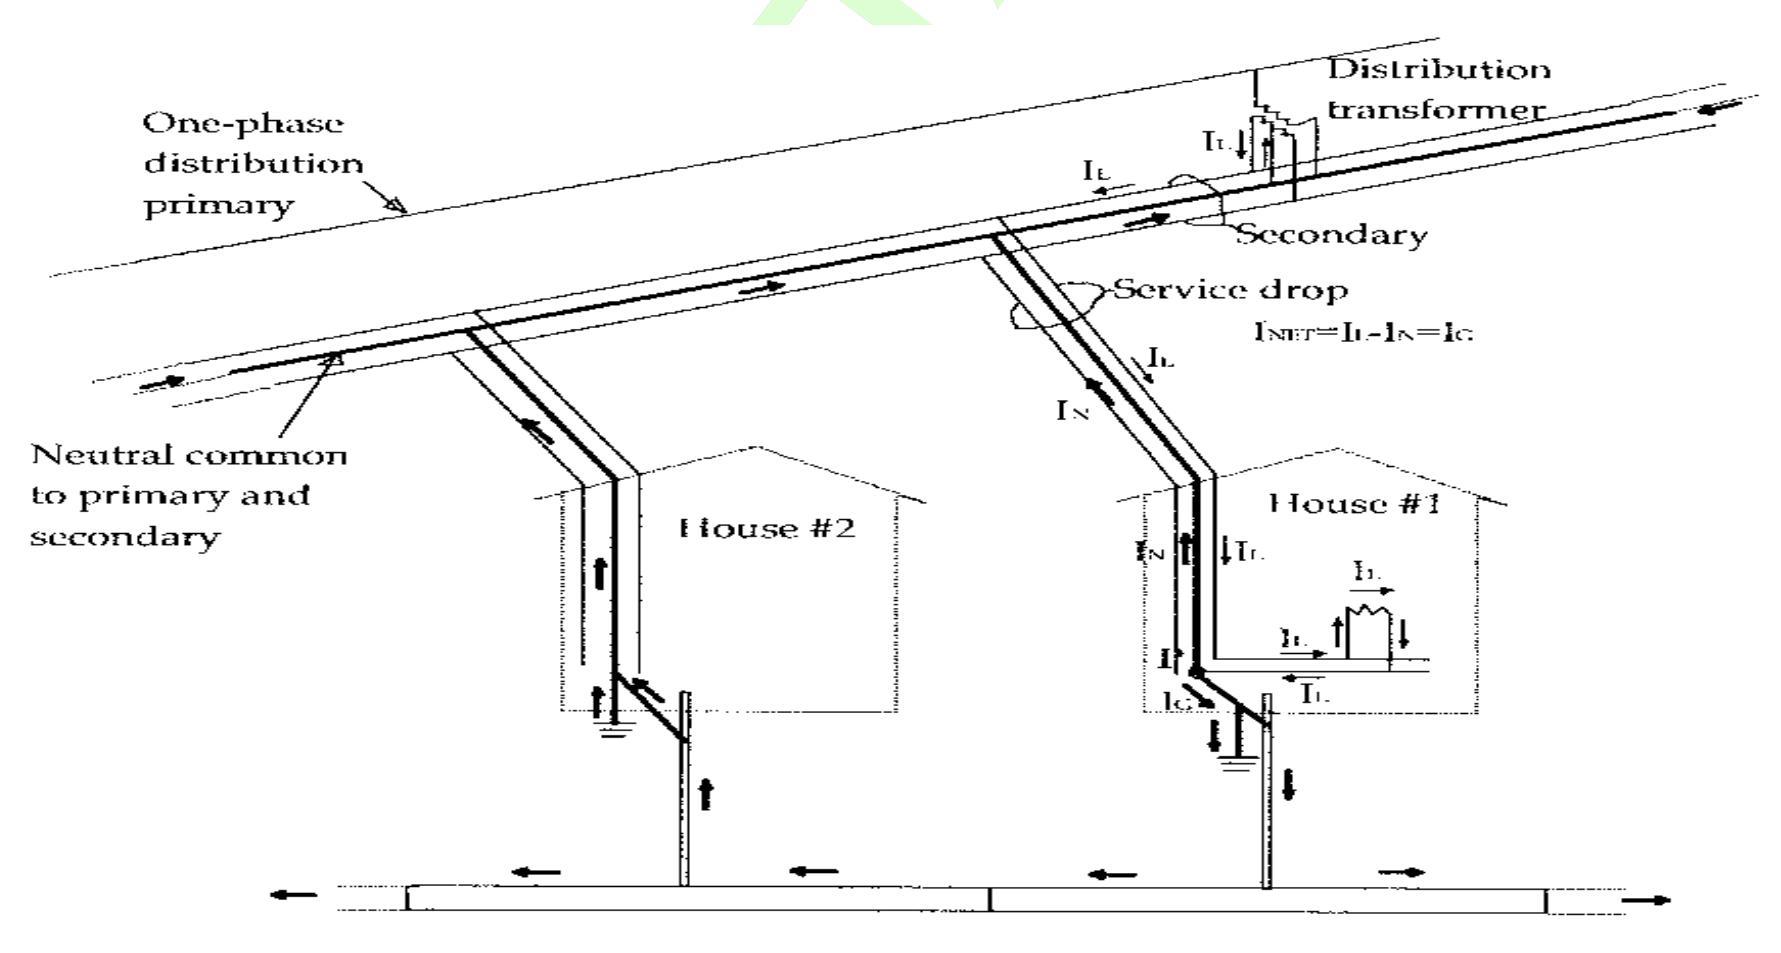
Ground Currents Caused by Residential Loads in a Typical Situation

In July 2002 during the peak summer load and *exceptional drought* conditions several JCP& L customers adjacent to the Herbertsville Substation on Driscol and Frede Drives in the Town of Brick, New Jersey, reported tingling sensations known as stray voltage while touching their pools, Jacuzzis, outdoor showers and other conductive objects. Testing revealed the problem still persisted with the main electrical panels de-energized (breakers or fuses open) indicating the stray currents (the cause of stray voltages) appeared to enter each residence from the utility pole via the overhead secondary service neutral conductor, which is bonded to the neutral-ground bus in each main electrical panel. Also grounded to the neutral-ground bus are the metallic water service pipe, ground rod, CATV and telephone drops (see diagram below for pictorial representation).

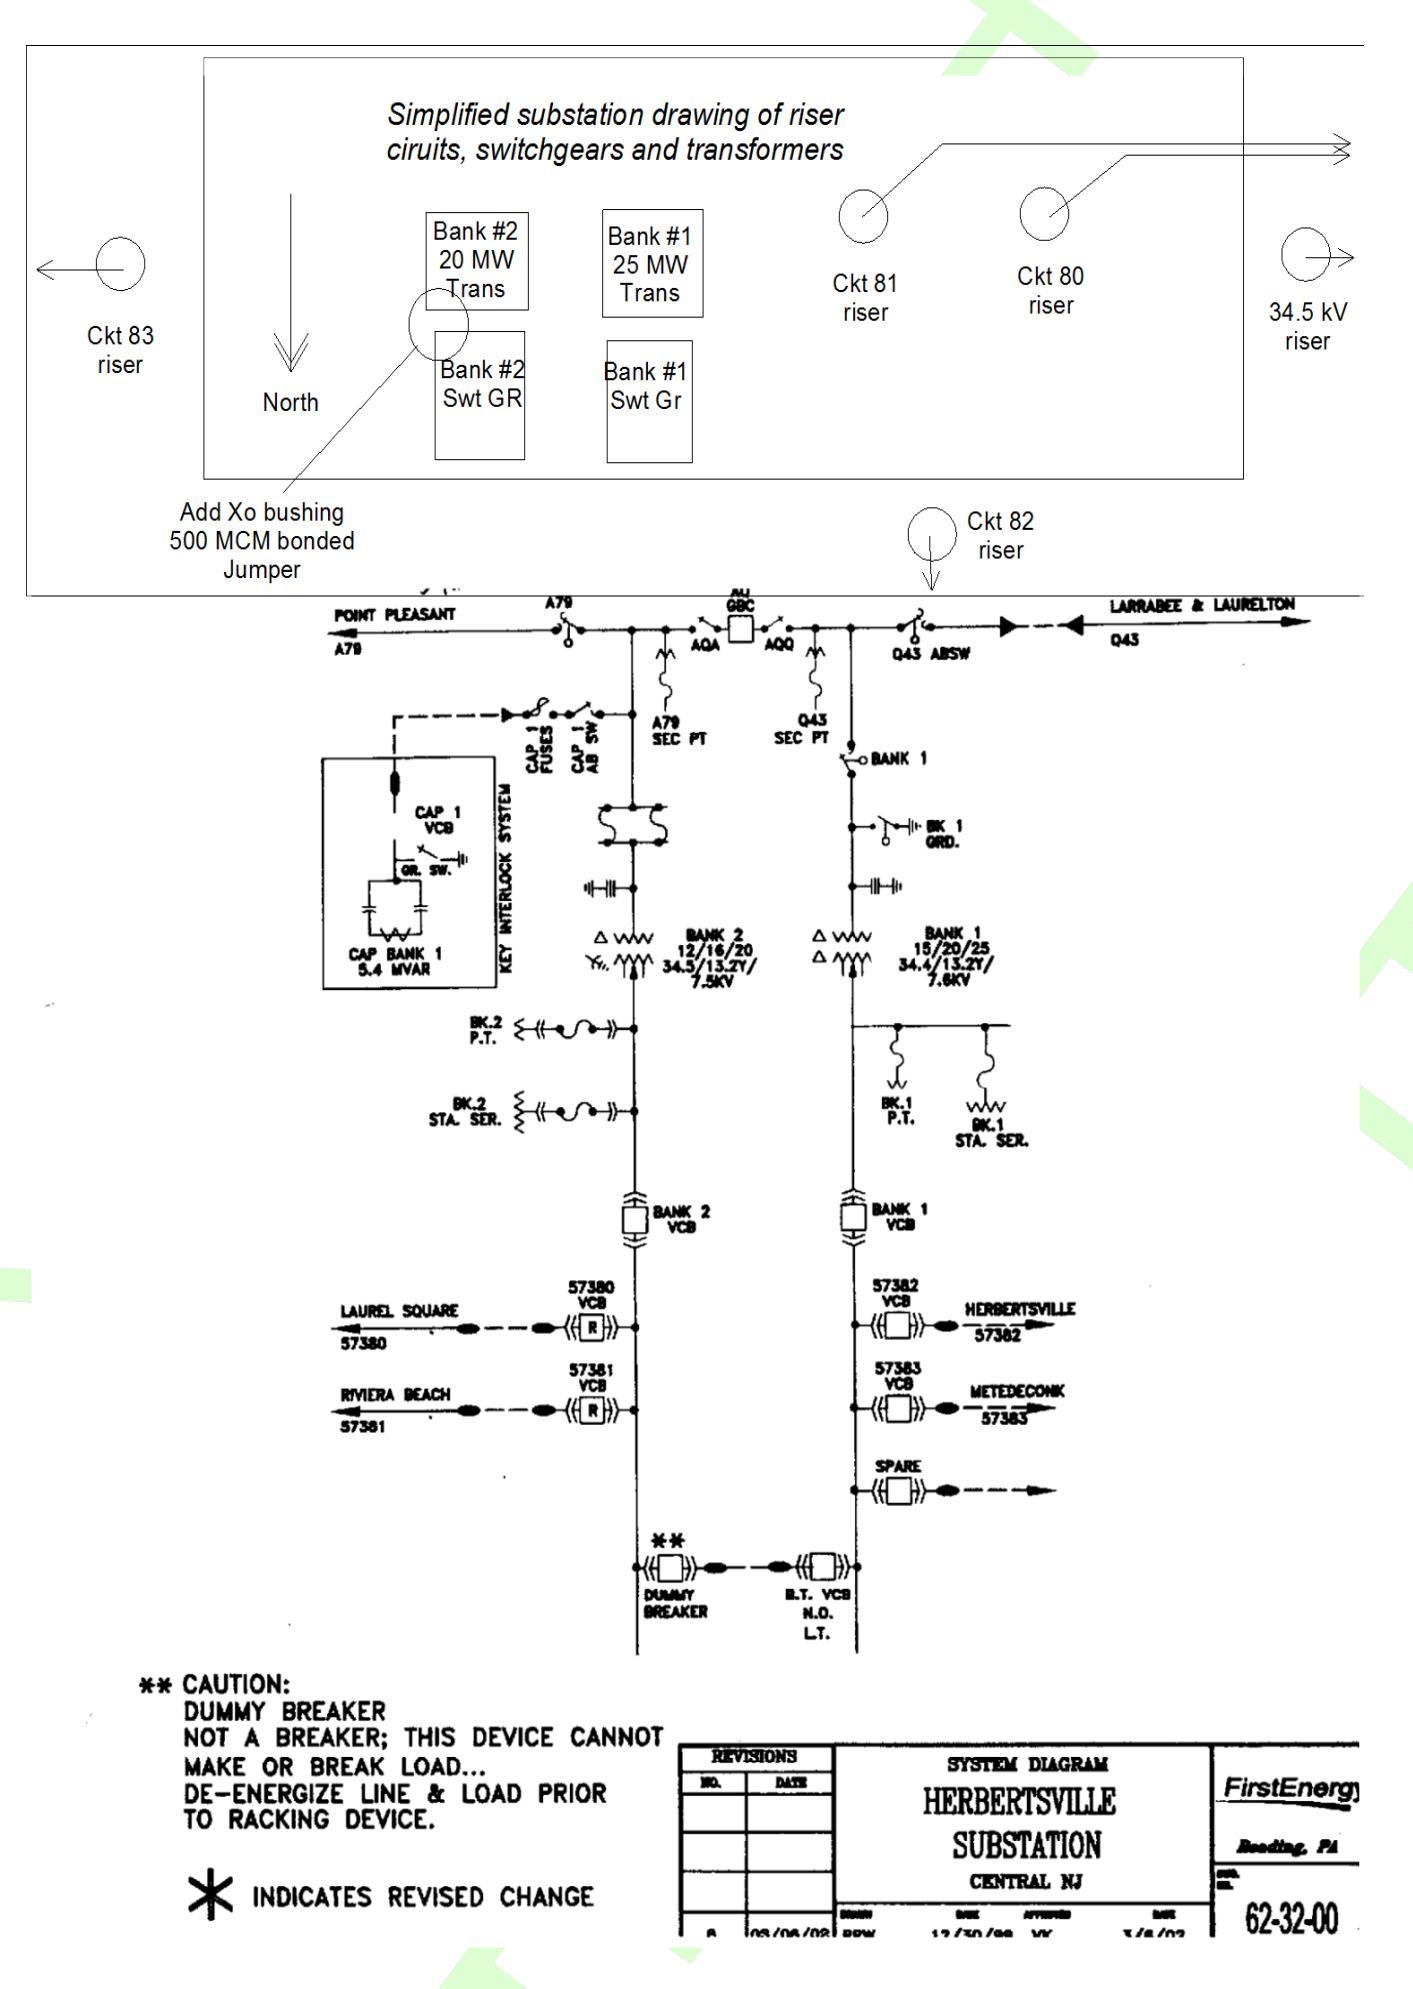
Figure #1, Herbertsville Substation Single Line Diagram

- Two 34.5 kV sub-transmission lines
- 25 MVA Transformer Bank #1 Circuits 82 & 83
- 20 MVA Transformer Bank #2 Circuits 80 & 81
- Upgraded Circuits 82 & 83 from 4.8 kV delta
- Primary Feeder Sizes: 397AA
- Neutral Feeder Sizes: Mix #2 ACSR and #2/0 AA
- Bank #2 Added 500 MCM Neutral From X0 bushing to Switchgear Neutral – No change in NEV

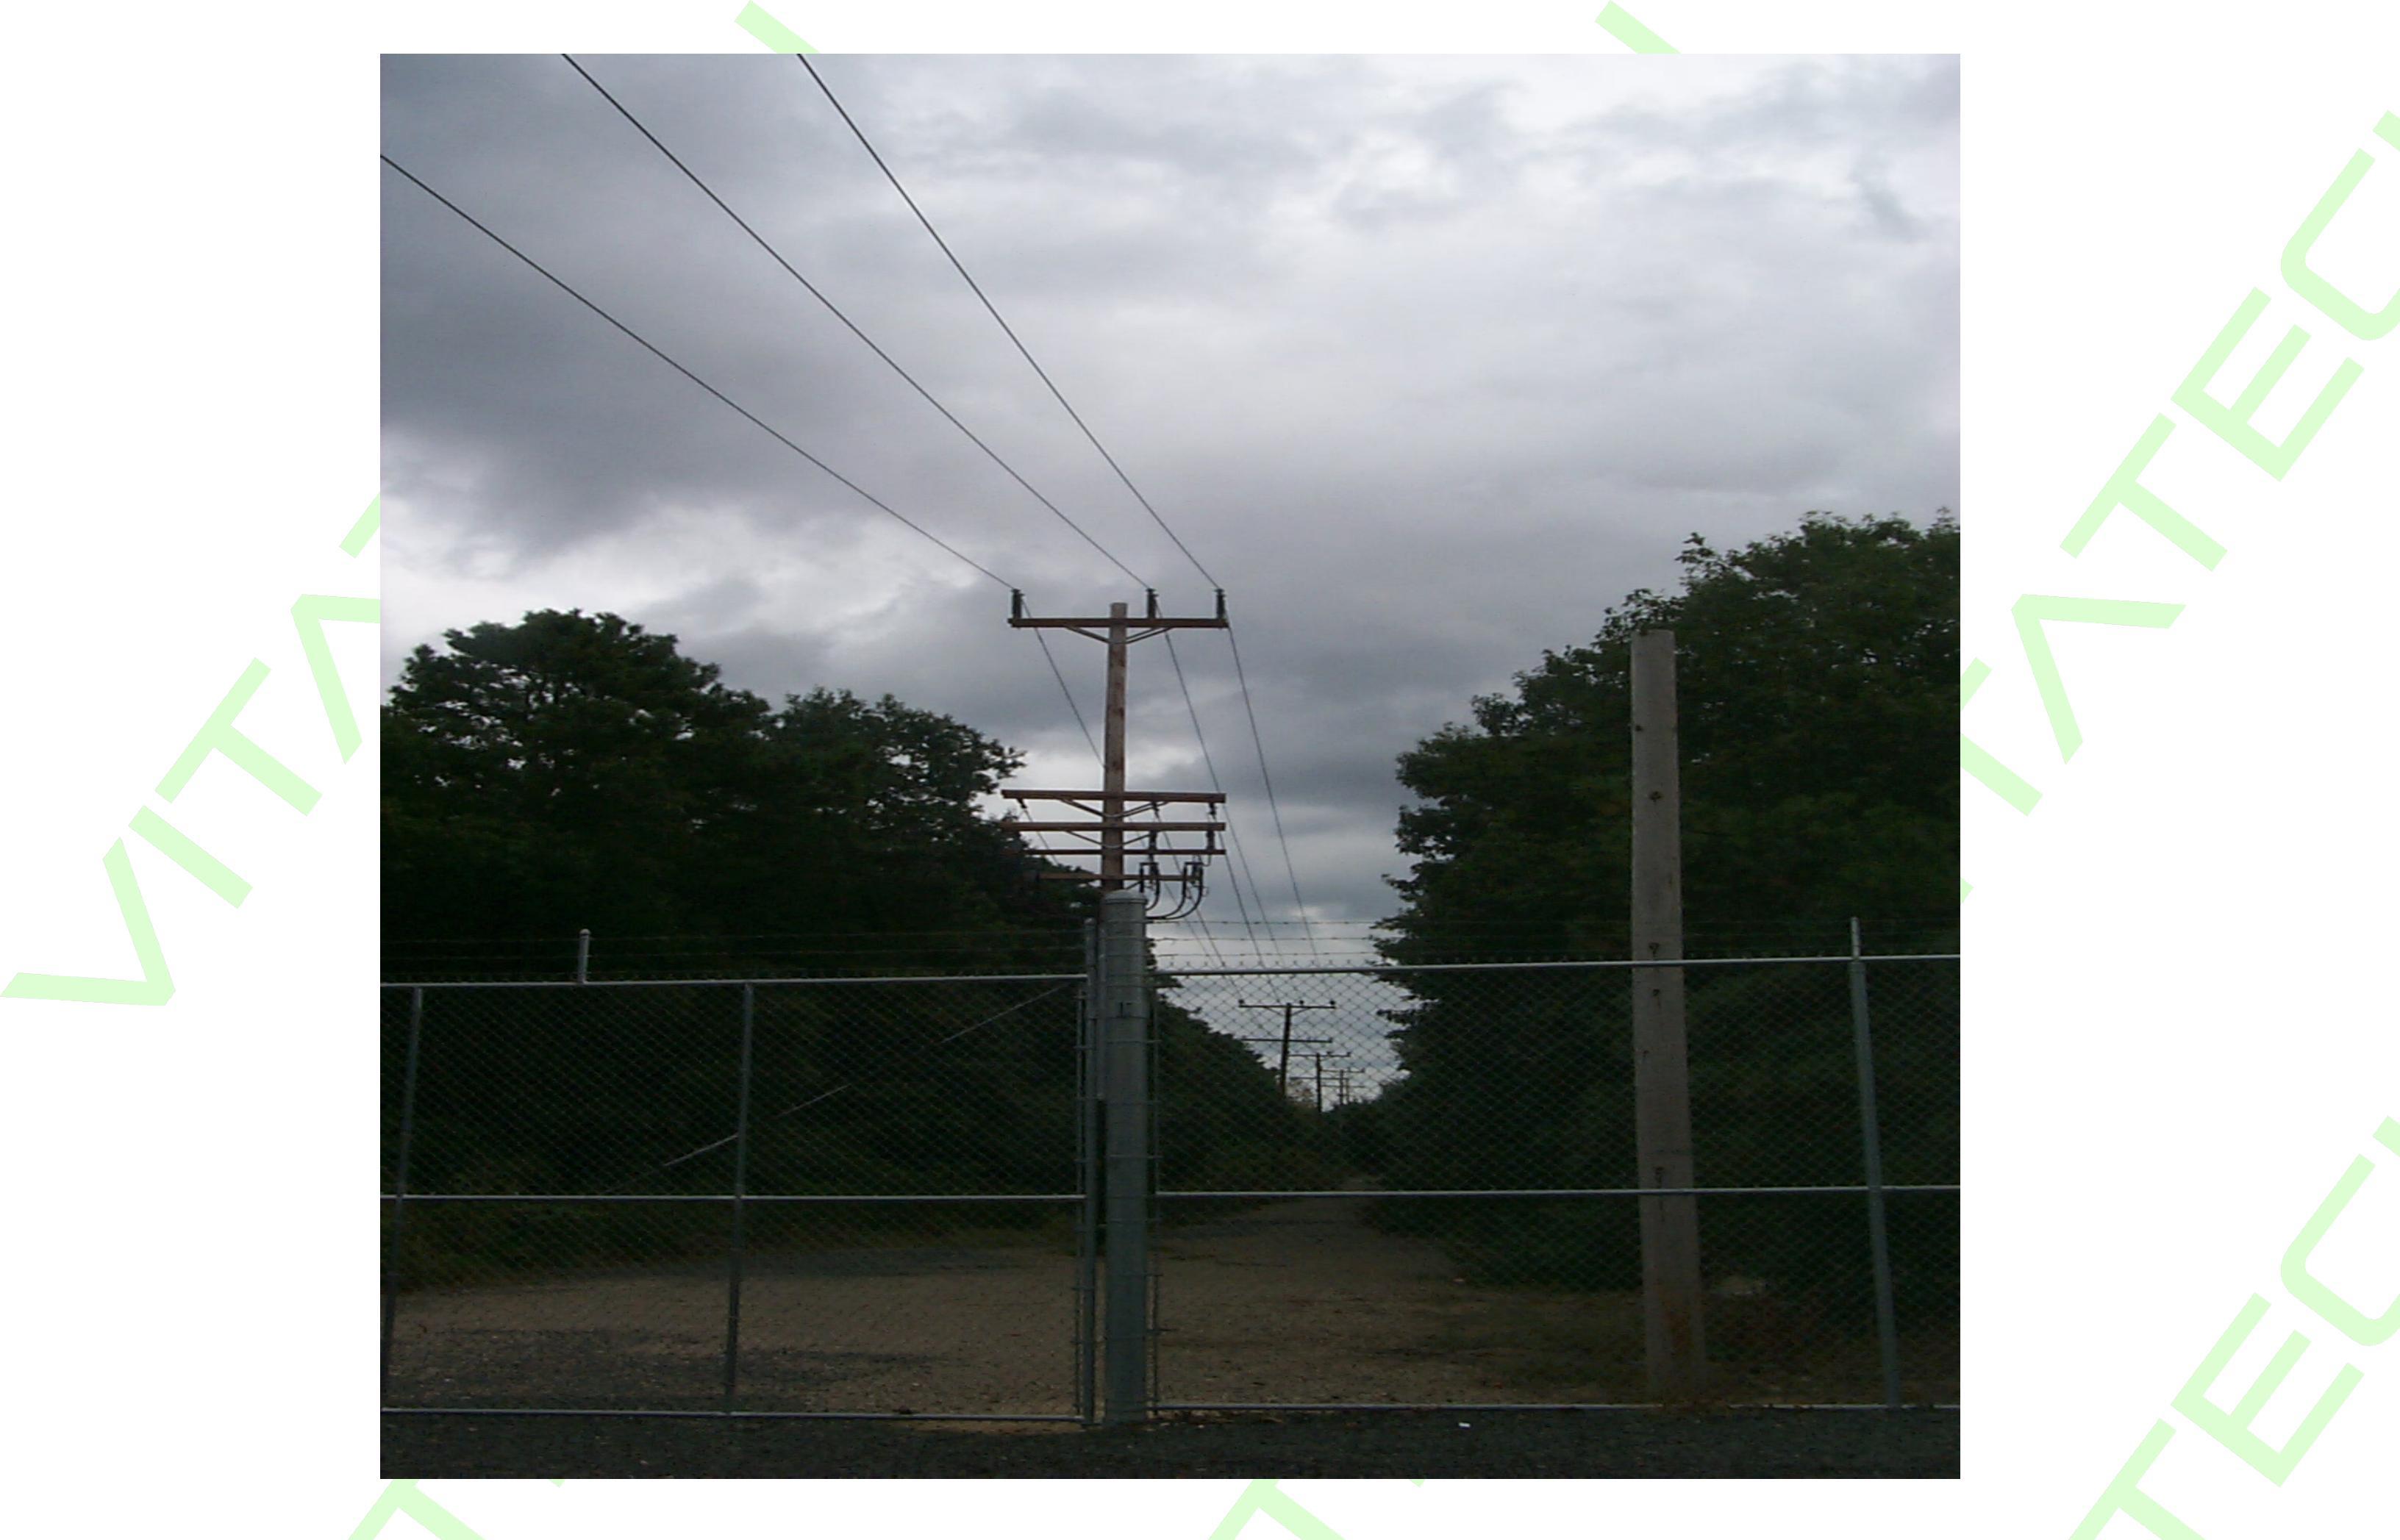
Herbertsville Substation Looking Eastward Circuit 83 & 34.5 kV

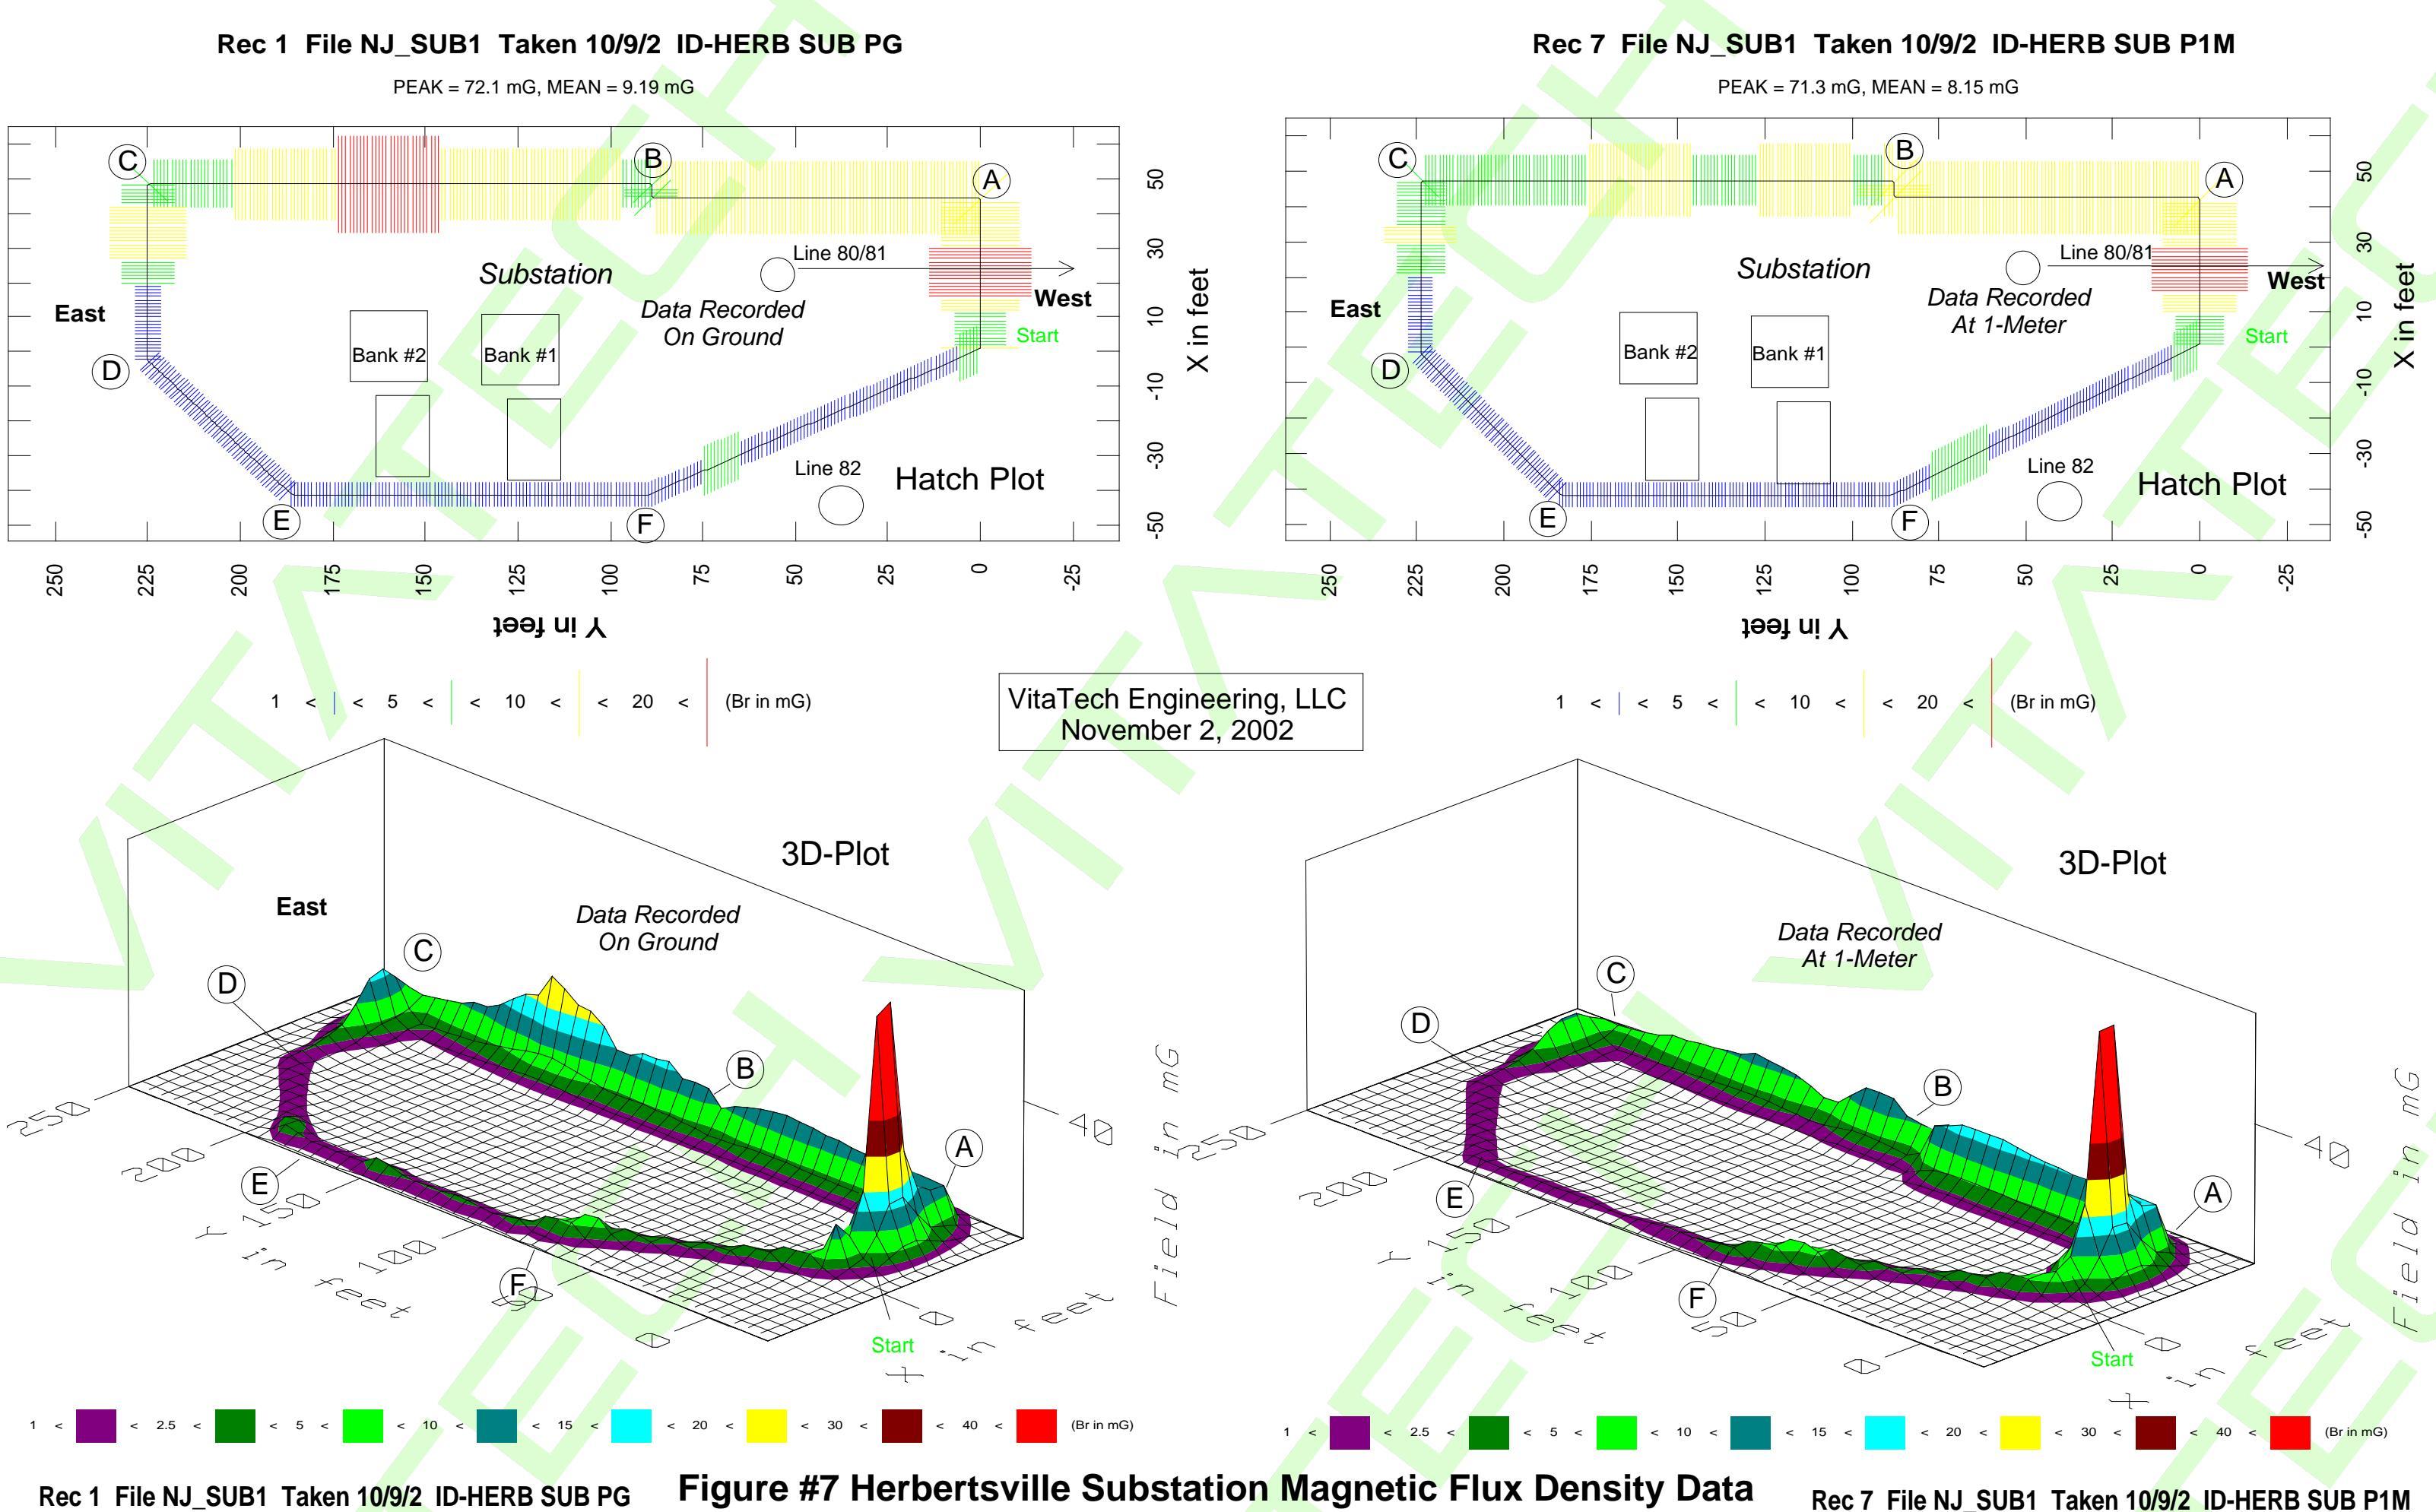
Figure #7 Herbertsville Substation Magnetic Flux Density Data Perimeter Hatch & Contour Plots At Ground & 1-meter Levels

Rec 1 File NJ SUB1 Taken 10/9/2 ID-HERB SUB PG PEAK = 72.1 mG, MEAN = 9.19 mG, STD = 8.51 mG, MEDIAN = 7.44 mG

PEAK = 71.3 mG, MEAN = 8.15 mG, STD = 8.01 mG, MEDIAN = 6.28 mG
